Third Technical Evaluation of Infrastructure June 2017

National Program for Village Development (PNDS)

Final Report

Findings and Recommendations

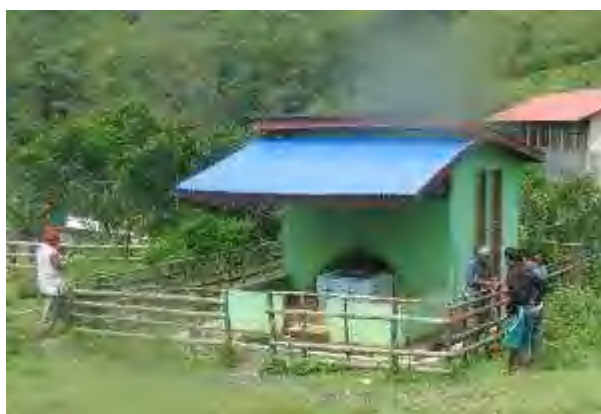
- A sanitation and washing facility in Suku Foholau, AP Turiscaí, Manufahi has been added off to the side of a community building in this village.

The villagers have maintained the fence and pathways that lead to this facility. The building is used regularly by most of the villagers who live in this aldeia. Toilets, showers and a communal laundry tub make this a focal point of the village.

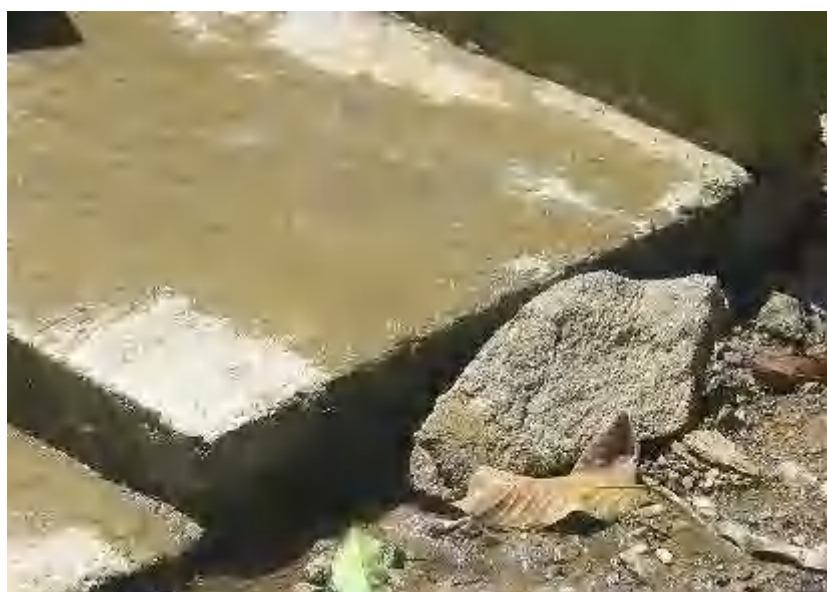
This tapstand has been constructed high above the natural grade. One can see where the villagers have inserted a sloped rock to enable their one-wheeled water carrying cart access.

PNDS TF and SF must spend time ensuring that this does not happen!

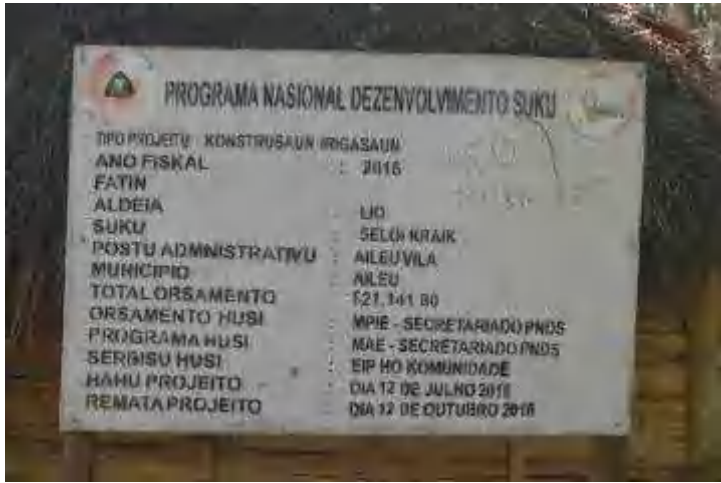
<p>The sub-project's information board installed is still quite good. With the existence of this project board and the condition is still quite good indicating the existence of transparency process in Selo Craic.</p>

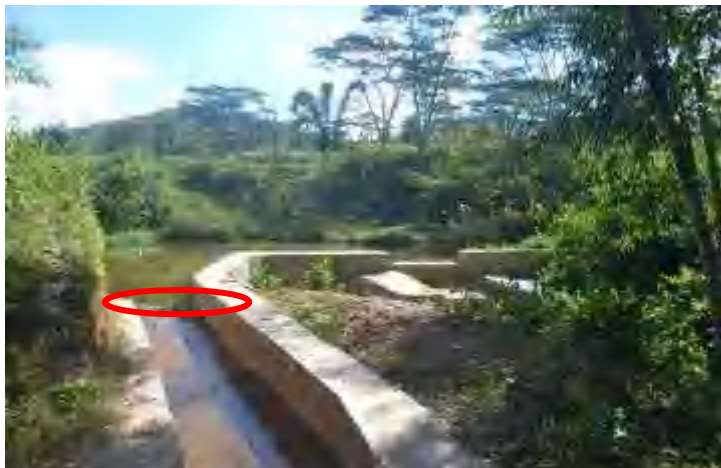
<p>The weir is functional and is used by the community, but the water gate, which serves to regulate the water elevation has not been installed. This even though the material for the water gate was available.</p>

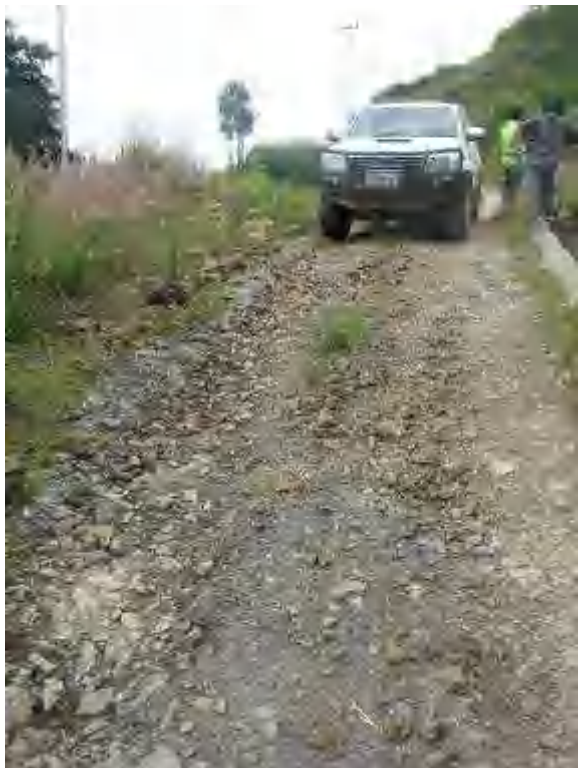
<p>This section of road had a new layer of gravel added. It has rapidly degraded again, with road rutting, corrugations and surface drainage problem evident.</p>

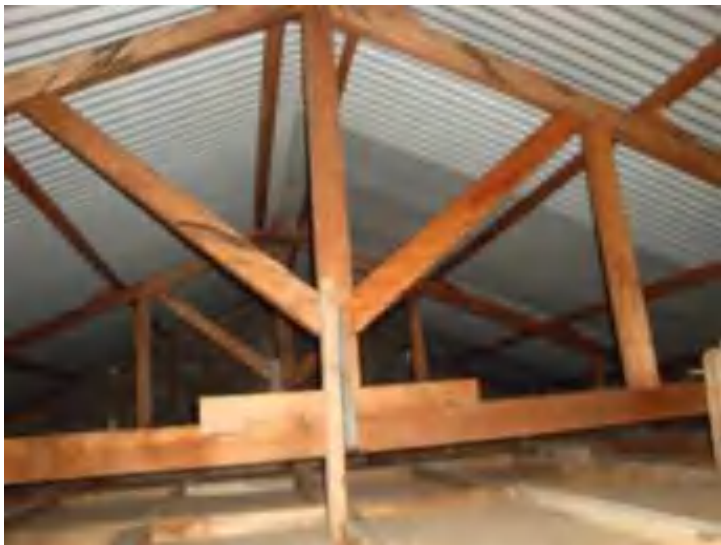
<p>A well-executed roof truss.</p> <p>It would have been better if the connections between the beams had been reinforced with a steel plate and bolts. This would have been stronger than just using nails.</p>

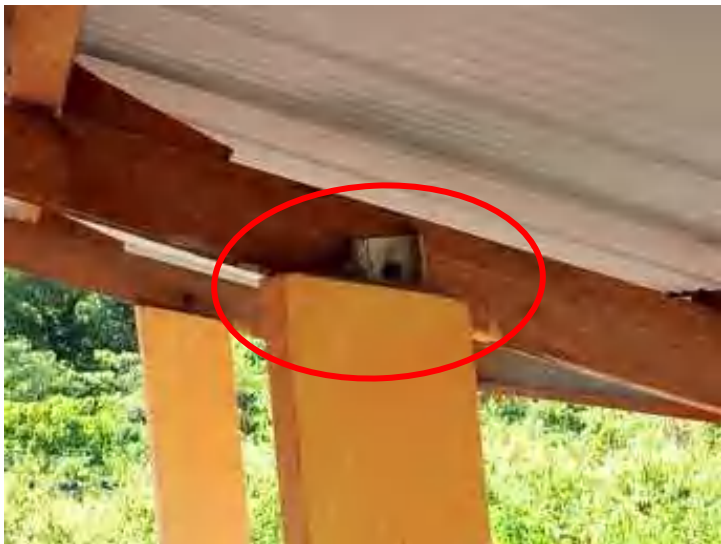
<p>The connection between the columns on the terrace and the wooden beams uses a steel profile, reinforced with steel bolts.</p> <p>This is very good practice, and can serve as an example for other buildings under construction or planned.</p>

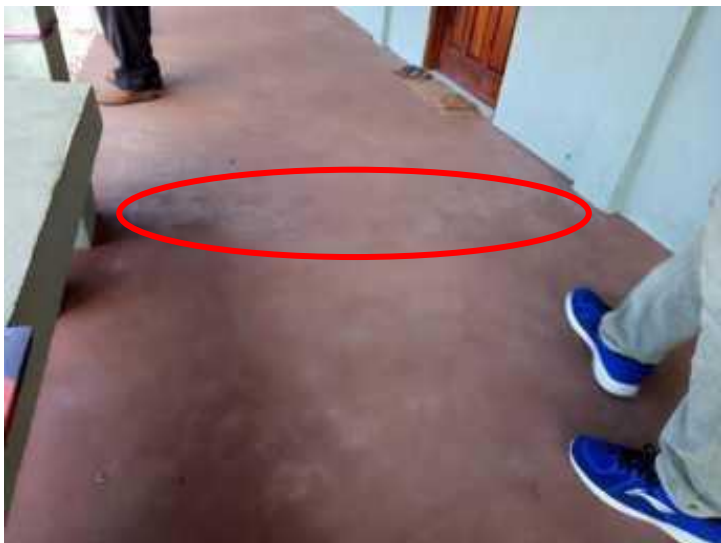
<p>There is a crack in the floor, which is caused by inadequate soil compaction, and shrinkage of the floor plaster.</p> <p>The cause of the crack should be addressed. The floor should be opened, the soil filled up and properly compacted, and then cemented again.</p>

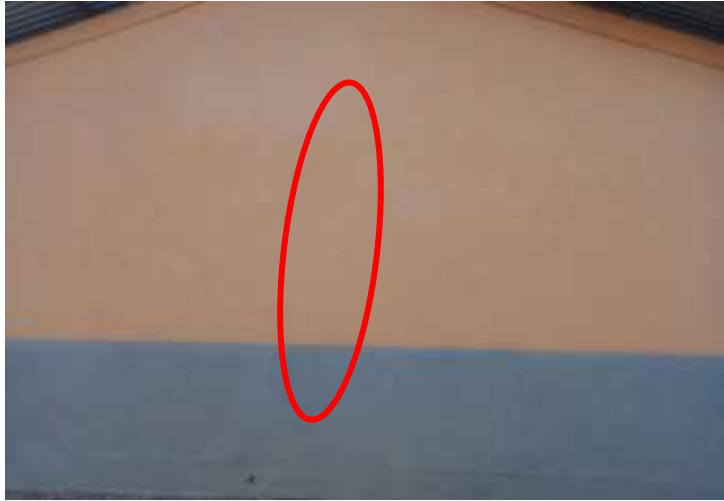
<p>In the wall, there is a hairline crack with a small width less than 2 mm.</p> <p>The evolution of the crack should be monitored.</p> <p>If the crack does not become bigger, then it is most likely caused by a poor plastering technique, but this is a non-structural damage.</p>

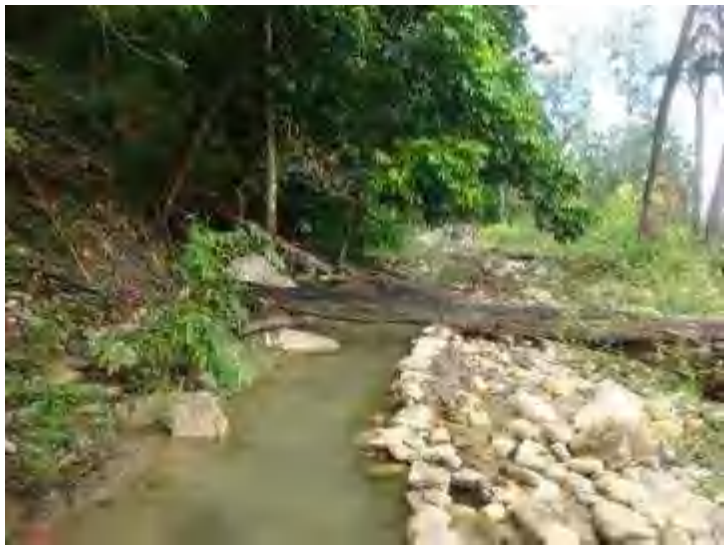
<p>The old water intake – parts of which still exist – was a small embankment of rocks and soil.</p>

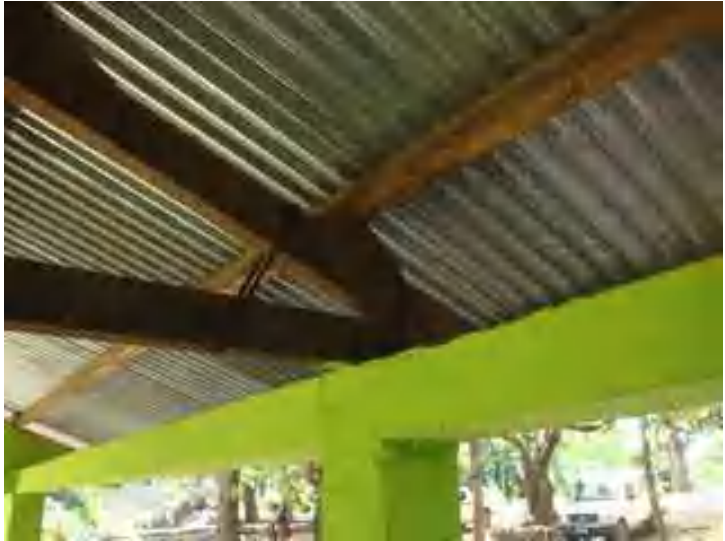
<p>The truss beams are tied to the columns with irons. This is not the best way to do it, as strong winds can still lift the roof.</p> <p>A better way to fix the roof trusses to the columns is with bolts and nuts to cast iron profiles fixed to the columns.</p>

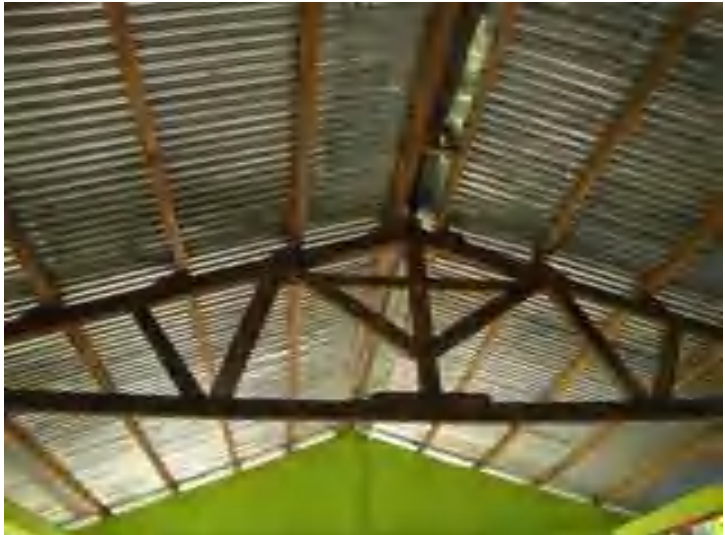
<p>The wooden truss is fixed with nails. It will be stronger if the connections are made with iron plates and nuts and bolts.</p>

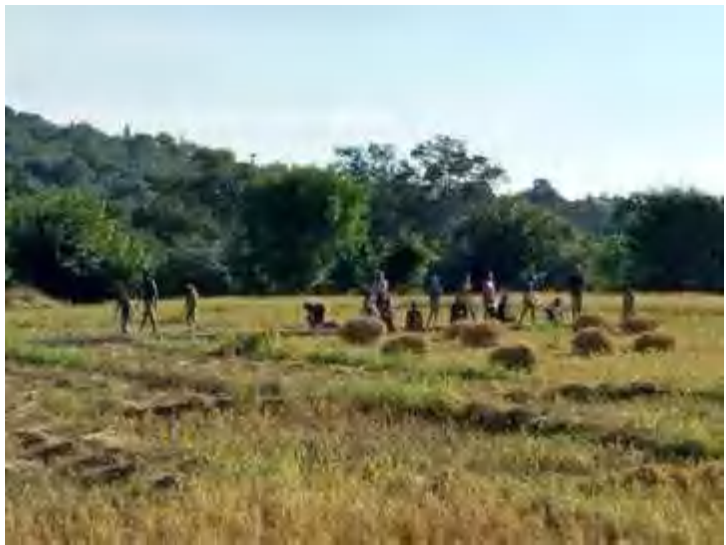
<p>Farmers harvesting paddy. They were happy with this irrigation sub-project as it brings more to their fields.</p>
 	<p>The construction of the irrigation canal is still very good after 10 months.</p> <p>The water diversion is still done in the traditional way by placing stones in the channel to be blocked, so that it flows into the other one.</p> <p>For similar sub-projects in future, it is recommended to construct a small diversion reservoir, where gates can be opened or closed by placing wooden boards into slots in the walls, as is the case at the water intake.</p>
 	<p>The irrigation channel is in excellent condition and well maintained.</p>
