Technical Evaluation of Infrastructure

National Program for Village Development (PNDS)

Final Report

Findings and Recommendations

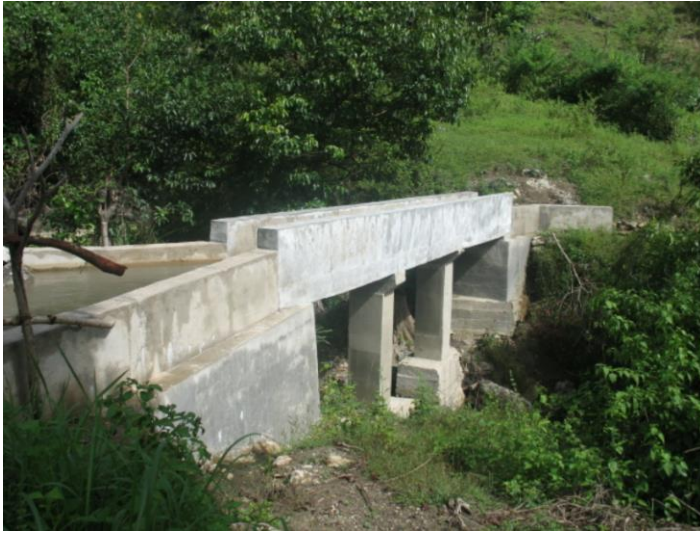
Pictured above is an innovative irrigation canal bridge that allows agricultural flows to pass over a small intersecting watercourse. This is a very imaginative and well-designed structure.

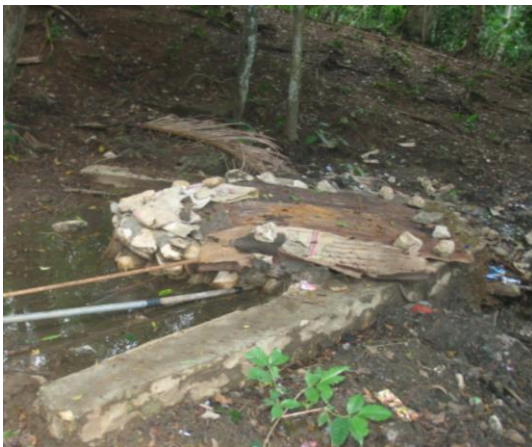
The disputed water source

The importance of ensuring that proper land donation documentation is completed for SP sites was demonstrated to the TE team in Suku Fohorem, AP Fohorem, Covalima. New gravity fed water supply works are underway in this village, with a catchment dam, reinforced concrete reservoir and several tapstands already complete. The landowner of the property containing the small spring, however, has withdrawn his permission for the works to carry on and be completed. The gentleman appeared during our visit, expressing very unhappy feelings about the project work

Recommendation 2: Copies of donation letters and TF 7.2.2 should be included in all Community Project Proposals. Senior PNDS personnel visiting SP sites should make periodic checks that all necessary and appropriately completed forms and documentation is in place.

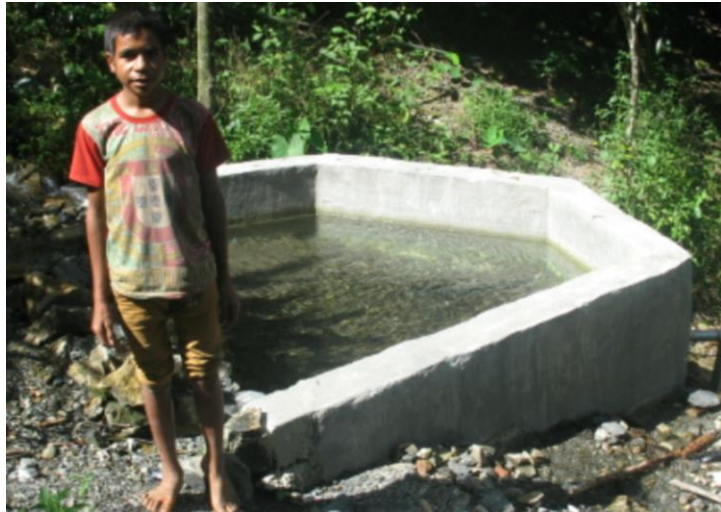
Catchment reservoir, Suku Leimea, Ermera

The Community Proposal for a gravity fed water system in Suku Leimea Leten, PA Atsabe, Ermera was noted to contain only a single 7.2.2 form, for a large aldeia and multi-faceted transmission, storage and distribution network. The form had been signed a local village elder on behalf of everyone in the village upon whose land the public works had taken place. A subsequent evaluation of another water system in this village, in another aldeia, displayed this same gentleman's name as the sole village signatory.

While it is laudable that Timor Leste villagers place a great amount of trust in elders to speak and represent them in public matters, PNDS facilitators must explain the importance and help in the creation of appropriate land donation documentation for each separate plot of land upon which SP works take place.

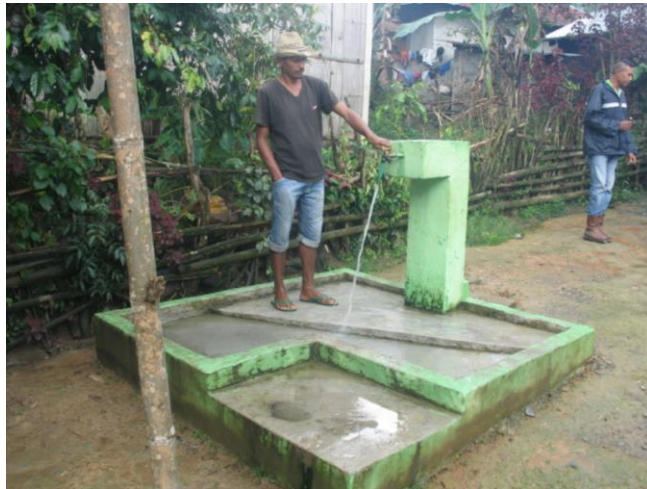
This tapstand has been constructed high above the ground surrounding it, creating a big step for users to negotiate as they leave, a hazard as they carry heavy buckets of water. The village implementation team explains that they did not build the ramp as shown in the drawings because no disabled people live in this neighbourhood. The TF reported that the construction of this tapstand happened between her inspection visits.

Recommendation 6: Tapstand ramps are an important part of these installations to guarantee easy and safe access for all users. Ramps should not be constructed steeper than 16% and should have rough/non-slip surfaces. Backfilling and compaction of granular materials should take place at the base of the ramp to join it with adjacent pathways. TF should ensure that the EIP do not remove them from the project design.
