# Technical Audit of Select Tonga Transport Sector Consolidation Project – Final Audit Report

General Routine and Periodic  
Maintenance Contract Works

Prepared for DFAT  
April 2014

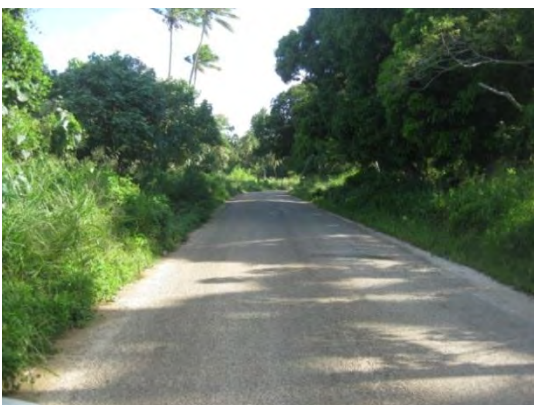
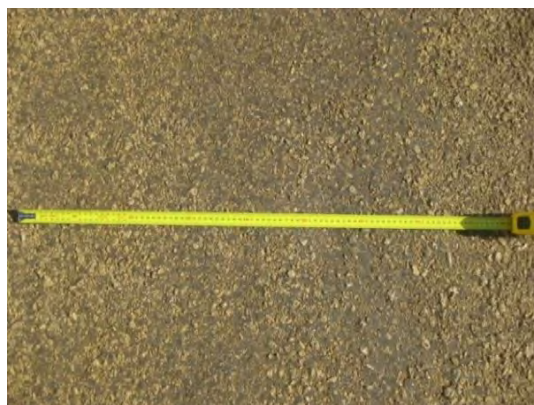
2. The best surface texture, with least localised deficiencies was the first Otta seal constructed on Fola Road using aggregates from Malopo quarry that fitted an Open Grading envelope. This is contrary to Section 8.3 of *A Guide to the Use of Otta Seals (1999)* by Norwegian Public Roads Administration (Otta Seal Guide), which specifies Open Grading only for low traffic volumes of less than 100 vehicles per day (vpd). Even though reliable traffic counts were not available, the general opinion of the Supervision Team was that all the Year 1 Otta sealed roads carried more than 100vpd.

Figure 1 Pilot Otta Seal on Folaha Road with the best surface texture after 12 months of traffic

3. Undertake increased supervision and implement Year 2 Specification on the construction of transverse and longitudinal joints between spray runs, to prevent surface defects and excess seal thickness.

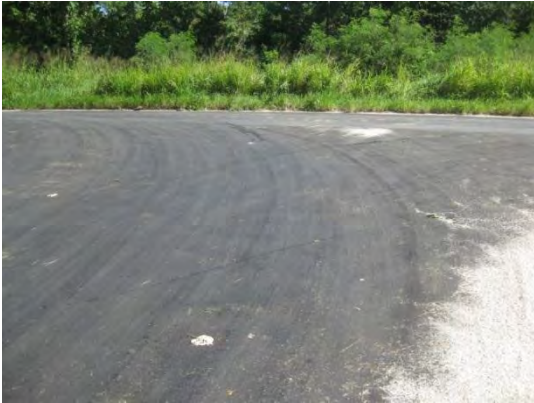
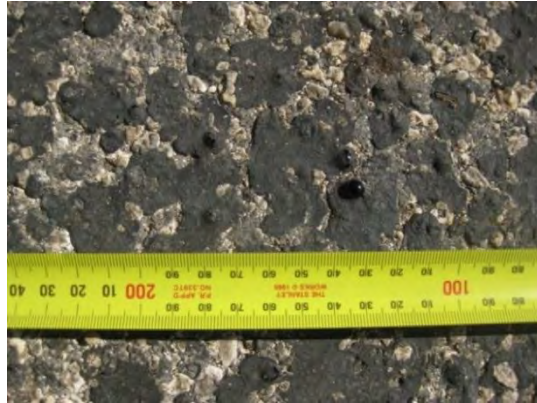
4. Localised deficiencies that need to be addressed in future construction and maintenance were:
  - (a) **Excess bitumen on surface at some intersections:** The excess bitumen at some intersections were due to either: double Otta seals applied to take the additional stresses of turning traffic; and / or, bitumen application using hand lances to wing sections where rate could not be controlled. The loss of traction due to excess bitumen is not considered a major traffic hazard due to lower speeds at intersections; however the Project Supervision team intended to rectify this by an appropriate treatment. The bitumen bubbles observed in hot weather at one of the locations indicates that the

Figure 2 Excess bitumen at Fonongahina Road and Liku Road intersection

*Excess bitumen*

*Bitumen bubbles on a warm day (same location)*

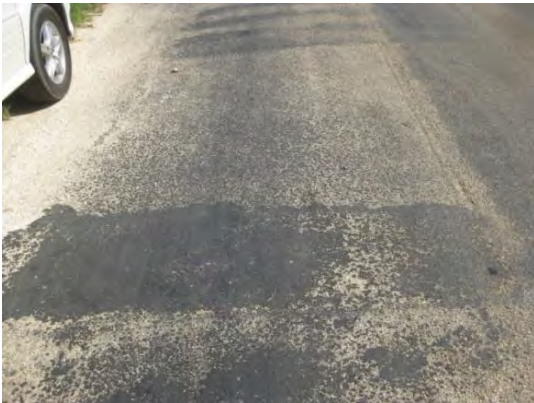
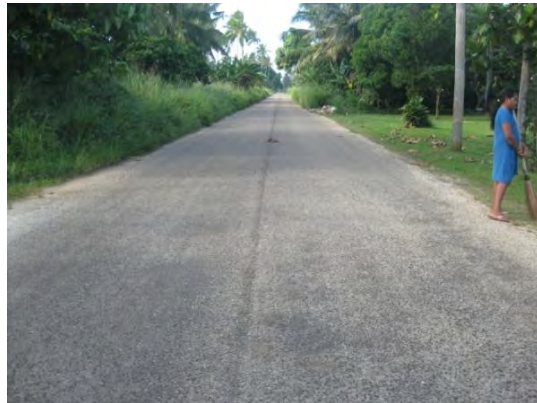
- (c) **Excess thickness along longitudinal joint:** Caused by overlap of the seals of each lane at the middle. This excess thickness is more pronounced in some early road sections (e.g. Folaha, 12 months old) and hardly noticeable in some later sections (e.g. Hufangalupe, six months). At worst locations this is about 15mm thick by 150mm wide. Year 2 Contracts include a work method for longitudinal joints to prevent this construction deficiency.

Figure 3 Stop-Start (Transverse) Joint Holoipepe Rd and Seal overlap at middle – Folaha Rd

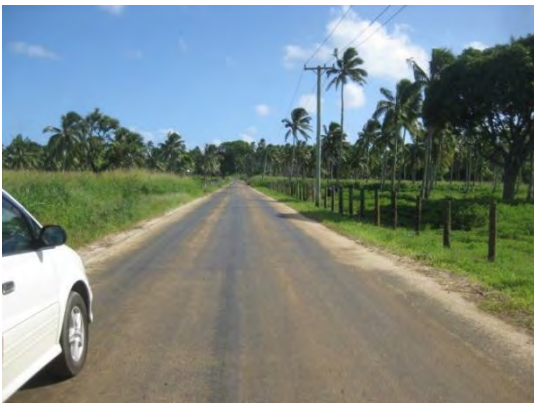
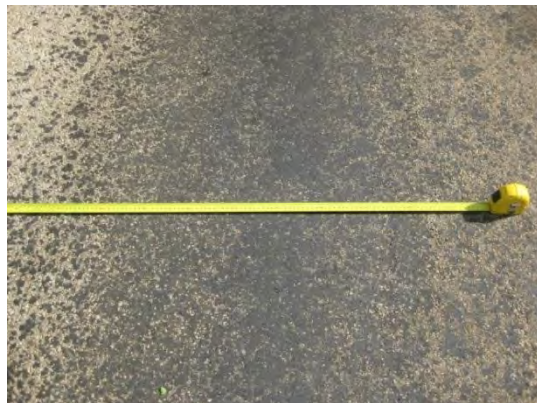
Figure 4 Apparent bleeding on wheel paths – Fonongahina Road

*View from a vehicle*

*Closer view of wheel path*

4. Undertake appropriate testing to determine adequacy of skid resistance on sections of wheel paths with apparent excess bitumen.
5. Seek information on failure modes and maintenance needs of Otta Seals constructed in other countries, in order to develop a maintenance regime for Otta seals in Tonga.

#	Draft Audit Report Section	Comment	Audit Response
15		Also is the asphalt bleeding a safety hazard?	Asphalt bleeding generally causes a safety hazard by lowering skid resistance. Section 3.1, Finding 3.1.1, Recommendation 4 was raised to assess this.
16		It is a good idea to get simple (and low-cost) data on the skid resistance of the Otta seals. Although there is little traffic, given this is an experiment case of new technology in Tonga, it would be good to have this sort of information. The auditor picked up that the although the surface appeared smooth given the amount of bleeding, on closer inspection there was an aggregate matrix flush with the surface, and it would be nice to note what impact this has on the performance of the road (such as skid resistance) and monitored in the future. It may not be necessary to use a pendulum tester to do so. The sand patch test is an easy method to measure texture, as mentioned in the report.	Comment agreed, however the pendulum test for skid resistance is not very complicated and the equipment is not overly expensive. No amendments made to the Report as a result of this comment.

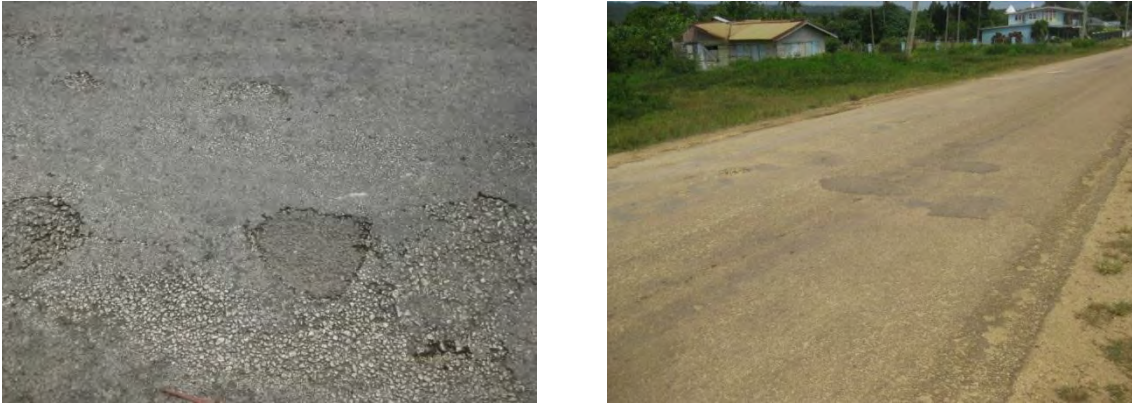
materials used in pothole patching. From the site inspections of the three Districts: Nuku'alofa, Hihifo, and 'Eua, there was no evidence of failed or re-patched pothole patches, however there were areas where new potholes were forming in the vicinity of previous pothole patches.

Figure 5 Pothole Patches on Hihifo Road and Pothole patches on 'Eua District

#	Draft Audit Report Section	Comment	Audit Response
5		Based on the photographic evidence, it does not appear that the potholes are being filled after squaring the holes and filling and compacting the pothole repair mix to a specified depth. The report should confirm the method of pothole repair. This may be one reason why new potholes are forming adjacent to filled ones: the full extent of the damaged pavement area is not being repaired.	The pothole repair procedure stipulated in Contract is similar to current accepted practice, i.e. require trimming sides vertical and bottom horizontal, however does not require squaring the pothole (as was the previous accepted practice). By inspecting the repaired potholes it was difficult to determine whether the procedure was compiled or not.
6		The report does not provide an assessment of other routine maintenance activities: clearing drains, vegetation control, shoulder repair etc.	Due to the time lapse (6 months) since the last routine maintenance contract activity it was difficult to comment on how effective these activities were undertaken. Also, routine maintenance undertaken by MoI during this 6 month period to keep roads safe has assisted in the general upkeep of the road environment.
