Third Technical Evaluation of Infrastructure June 2017

National Program for Village Development (PNDS)

Final Report

Findings and Recommendations

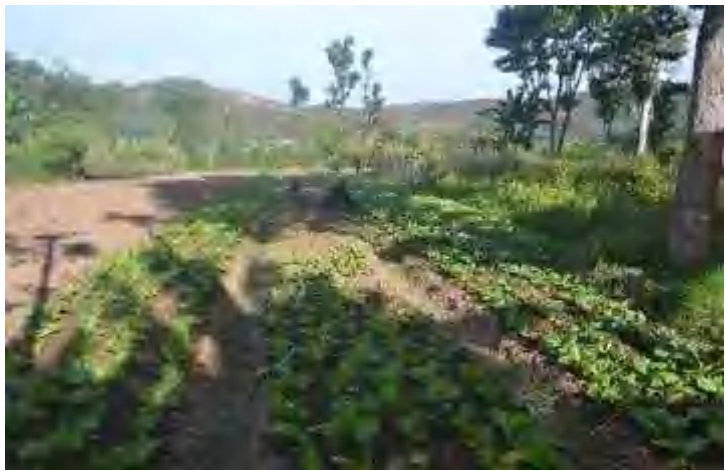
<p>A vegetable farmer said that the irrigation channel has made it easier to develop his vegetable business. They can now water the plants with an electric pump, and grow vegetables much easier than before. Before they had to walk to get the water, which took a lot of time and energy.</p> <p>This vegetable grower has now become a regular supplier to Dili Mart, and they come periodically to the farm to buy his vegetables.</p>

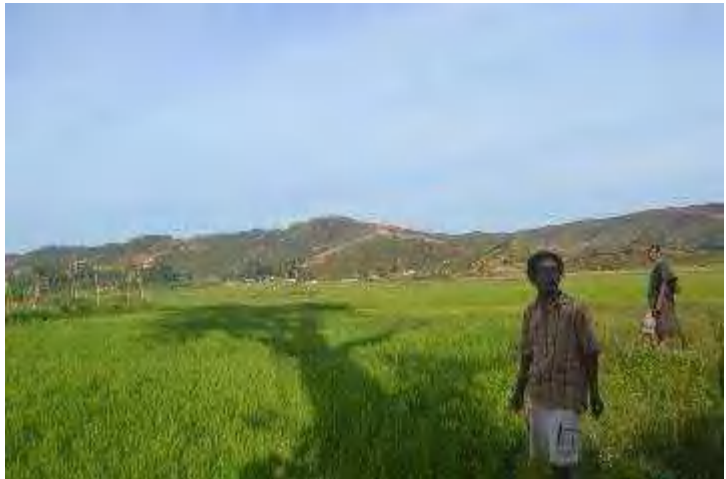
<p>Before the construction of the weir, this was 'sleeping land'. In 2017 farmers started to cultivate these fields again.</p> <p>They estimate that they have been able to take another 2 ha into cultivation.</p>

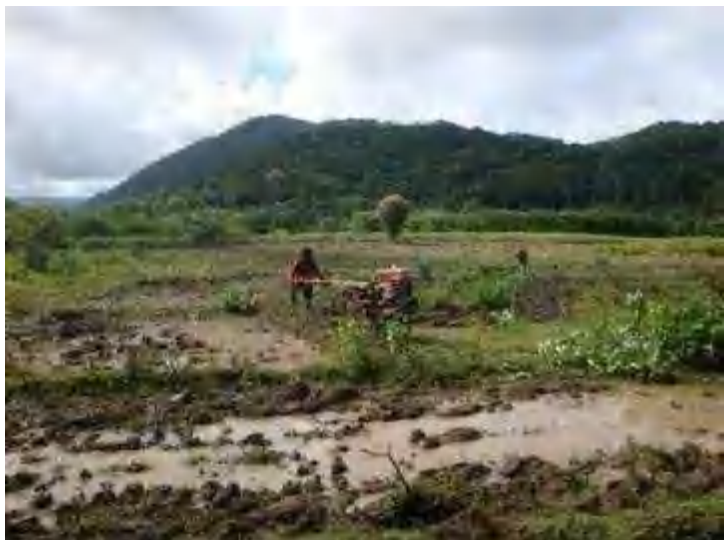
<p>Paddy fields are irrigated with water from this sub-project.</p>

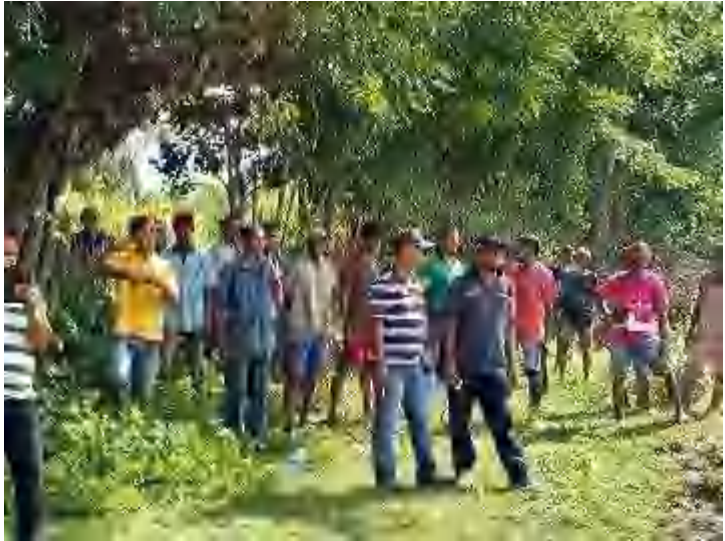
<p>Even though the irrigation channel is located far from the suku center, there was a lot of interest of the local community to follow and observe the technical audit visit.</p> <p>It is a sign of a high sense of ownership and participation in the implementation of the PNDS sub-project.</p>

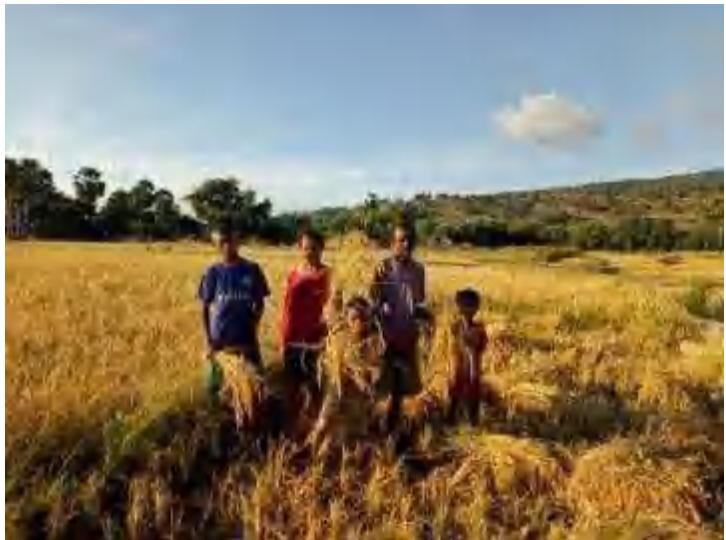
<p>Domingoes Ico, one of the family farmers was interviewed when harvesting.</p> <p>He expected that his paddy harvest would increase quite a lot. The previous year he harvested 6 sacks @ 50kg, and he expected that this harvest would reach 10 sacks, which means an increase of 4 sacks, or an increase of 60%.</p>
