Technical Evaluation of Infrastructure, 2015

National Program for Village Development (PNDS)

Final Report

Findings and Recommendations

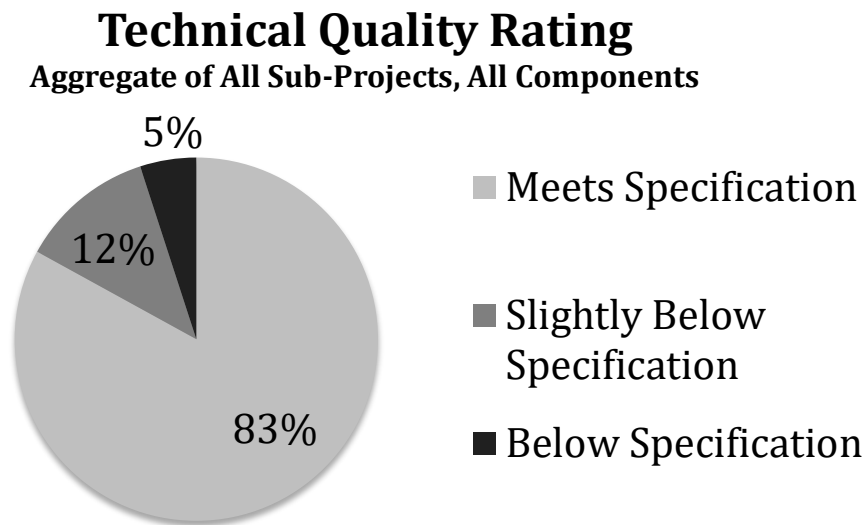
Chart 1: Technical Quality Rating of Sub-Project Construction

The chart below presents this finding using an aggregate of all of the technical components of the sub-projects evaluated.

- **Considering the aggregated total of all sub-projects evaluated, it was found that 83% of the technical components of the structures have been constructed in accordance with the plans and specifications as set out in the Community Project Proposals.** Bridge sub-projects were found on the

higher side of this – 97% of technical components were found meeting specification (4 sub-projects were evaluated). Road and drainage sub-projects were noted to be failing in many more respects, with only 52% of technical components observed to be meeting the PNDS specifications (5 sub-projects evaluated). Buildings and water supply sub-project components were found to meet specification 84% and 81% respectively.

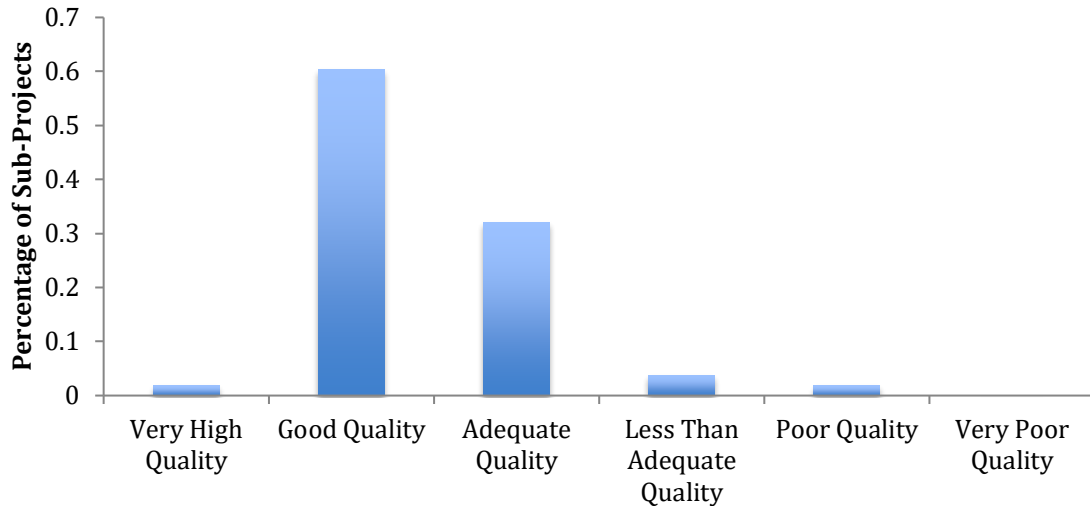
Chart 2: Sub-project Quality Rating

Government of Australia Aid Program's Quality Rating

Higher ratings might also be deemed suitable when combined with solid community participation during construction or visibly high use of the infrastructure during the site visit; all of these social aspects of sub-projects can combine to move a technically 'so-so' sub-project higher in its overall quality rating.

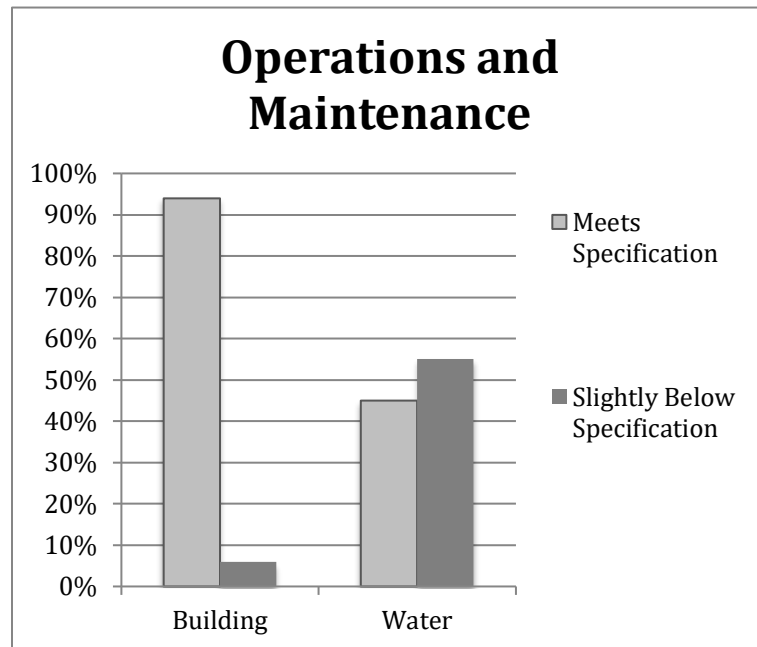
Chart 6: Operations and Maintenance, Building and Water Supply

Water systems should have a community level water user group organized after the construction period called a GMF (Grupu Maneja Fasilidade). The village EOM should help to facilitate this if there is not one set up. Some of these EOM teams did not seem to be very active – we inspected many reservoirs that had not been cleaned in over a year. Most systems are not yet collecting any user fees from the villagers. We heard from several EOM that the setting and collection of fees to pay for system maintenance was being discussed at aldeia meetings, but that no firm plans to institute a user fee had been made. It was not clear whether a GMF had been established to oversee the facilities.

None of the bridge, road or drainage infrastructure that the TE teams visited have been the subject of any major maintenance activities and EOM, if they exist, are not active and no village household user fees are being collected.
