Project Completion Report

AUSAID AGREEMENT NO.:	C061506
TODAY'S DATE:	31 st July 2012
ACTIVITY TITLE:	Tourist Jungle Trail - Peleliu Island
NAME OF IMPLEMENTING ORGANISATION: ACTIVITY MANAGER DETAILS:	Cleared Ground Demining Cassandra McKeown cassandra.mckeown@clearedground.org +680 345 1221 / 778 8042
TOTAL SGS AMOUNT APPROVED:	USD 49,173:80
TOTAL SGS FUNDS EXPENDED:	USD 48,895.48
Local Contribution:	USD 146,000:00
Other Donors:	USD 0
TOTAL:	USD 194,895.48

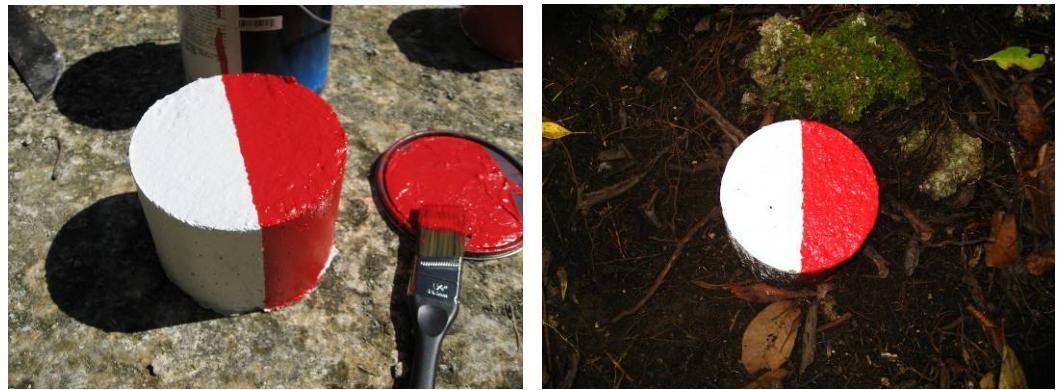
Photos 2: The concrete markers that line the tourist jungle trail.

Following ERW sub surface clearance operations the trail was marked with small red and white circular concrete markers. The markers are consistent with international best practice for marking minefields, and are designed so that they are laid every 5metres on either side of the trail with the white portion facing inwards and the red facing outwards, so the visitor then walks between the white trail that has been cleared. The concrete markers are 150mm in diameter and 250mm high. CGD's local team fabricated the markers, starting with making the mouldings for the pouring of the concrete.

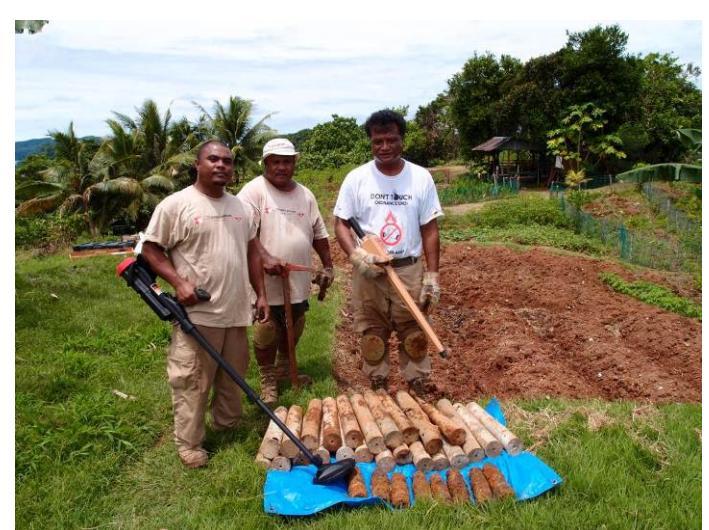
Photo 3: Emergency Task #: KOR 082 the removal of 32 items of ERW, adjacent to the main water supply tank in Koror State.

A significant emergency task was initiated following a report by a landowner / small holding farmer who had excavated a projectile whilst extending his tapioca growing area. Of particular importance is that the site is located directly adjacent to the main water supply tank in Meyuns, Koror State. Sub-surface investigations by the CGD team located a total of 32 items of ERW near to this major supply of water for Palau's most populous (10,000 people) State. Two other emergency tasks in Koror concerned significant holdings of unstable WWII ammunition, in one case some 1,053 SAA held by a member of the public and in another case 254 SAA found in the grounds of the National Hospital.

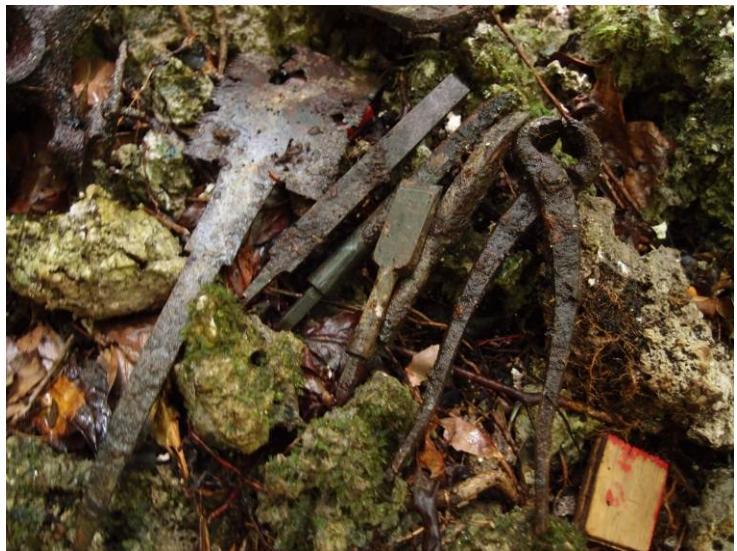
Photo 4: WWII artefacts located on the trail include this tool set

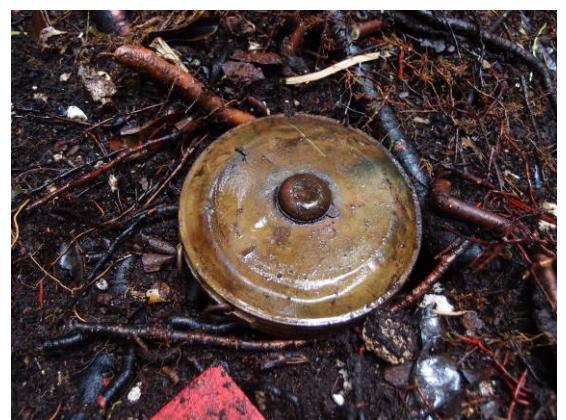
Photo 5: Type 93 Japanese Anti Personnel landmine located during trail clearance

Of particular importance was the location and removal of a Japanese Anti- Personnel landmine. AP landmines are an insidious weapon which are buried, and can be detonated in a manner of ways including by an individual treading on the unseen item. Today the production and use of AP mines are banned by over 160 countries under the Mine Ban Treaty. However, CGD does come across mines that appear to have been part of ordnance stored in the Peleliu cave systems. This location of this landmine suggests it was part of such a store of mines, rather than part of a formation laid under the soil.

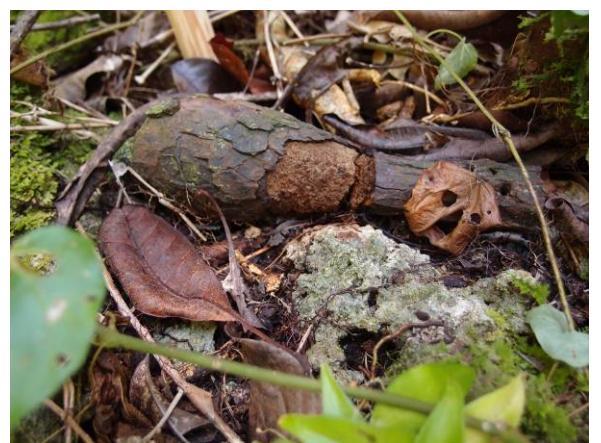
Photo 6: A deteriorating USA mortar with corroded outer case exposes high explosives to the elements.

The majority of post-conflict ERW clearance taking place globally deals with ordnance that is relatively new, when compared to the WWII ordnance found across the Pacific. The age of the ordnance found in the Pacific is unique and compounds the threat to the community, as the explosives can become destabilised over time and with exposure to the elements. Please see the below photo which shows how the rusting through of the munitions casing can leave raw explosives exposed.
